Test Report

Report No. A225055325110100113

No.	Test Item
1	Micro cross section inspection(OM)

Test Item: Micro cross section inspection(OM)

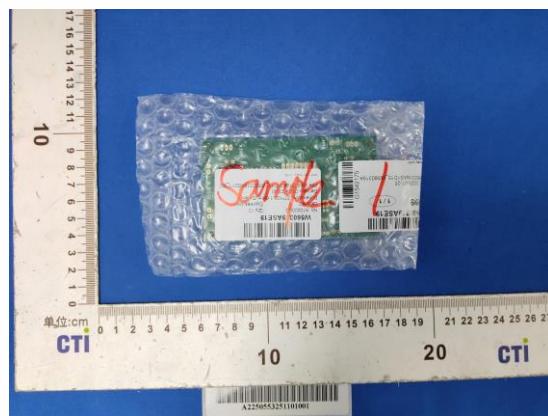
Sample No.	Sample Name	Material
A2250553251101001	sample1	pcb

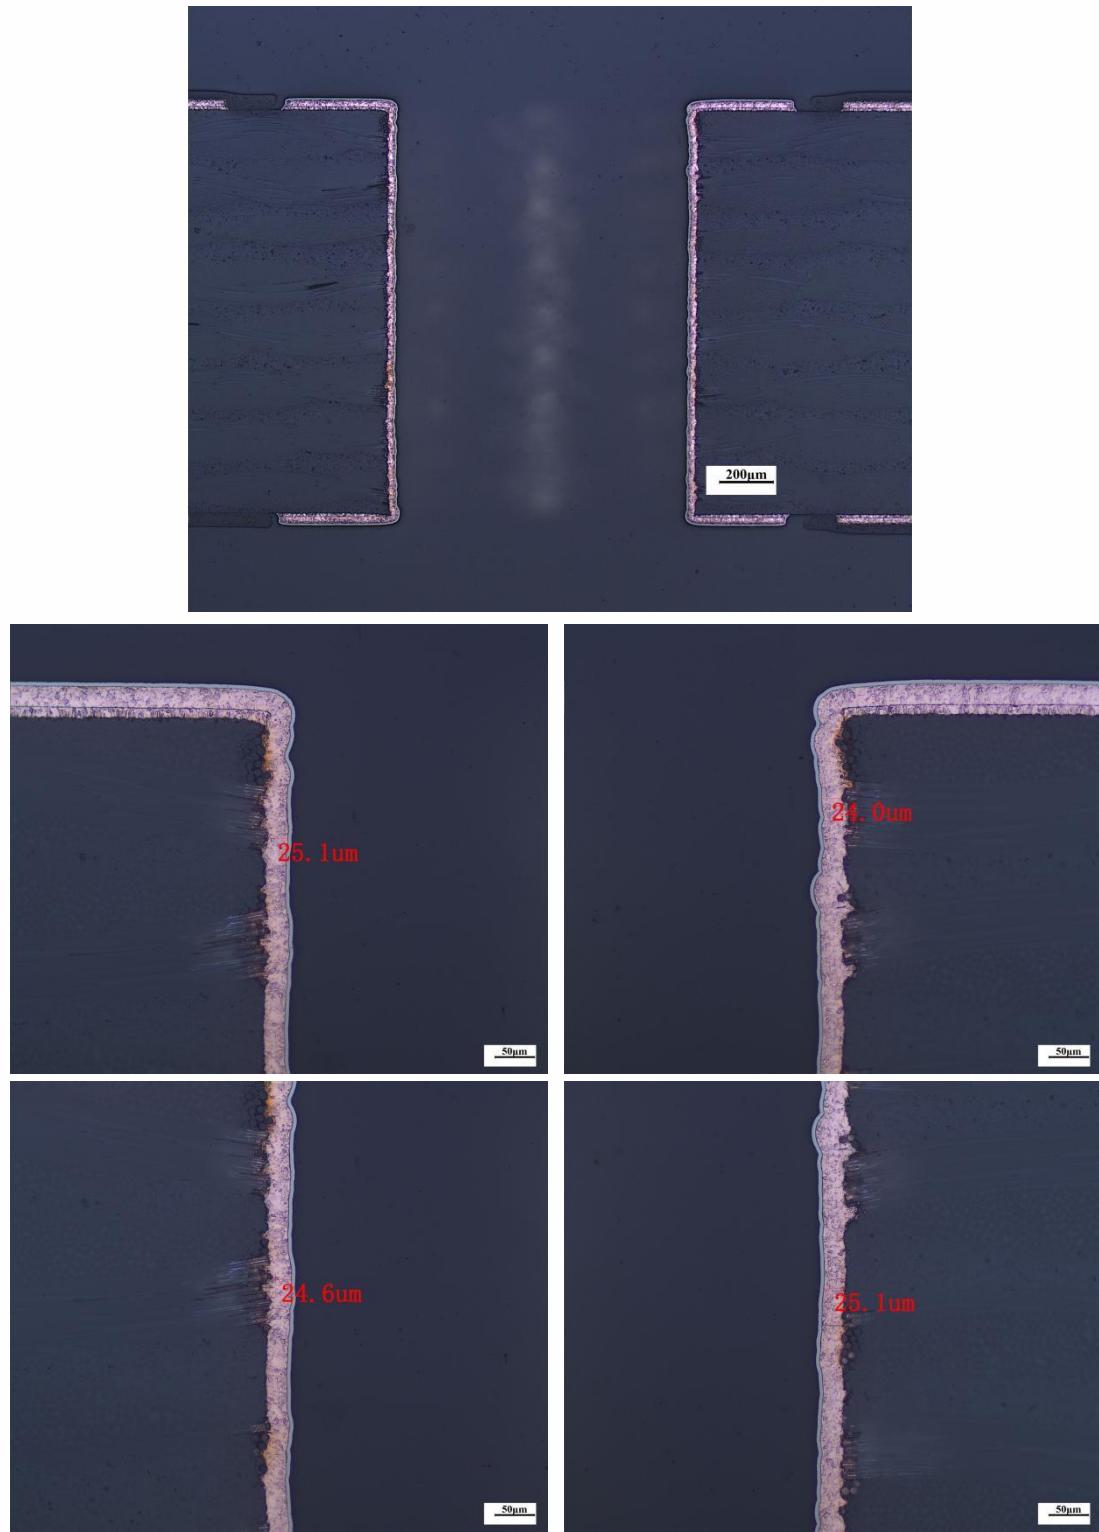
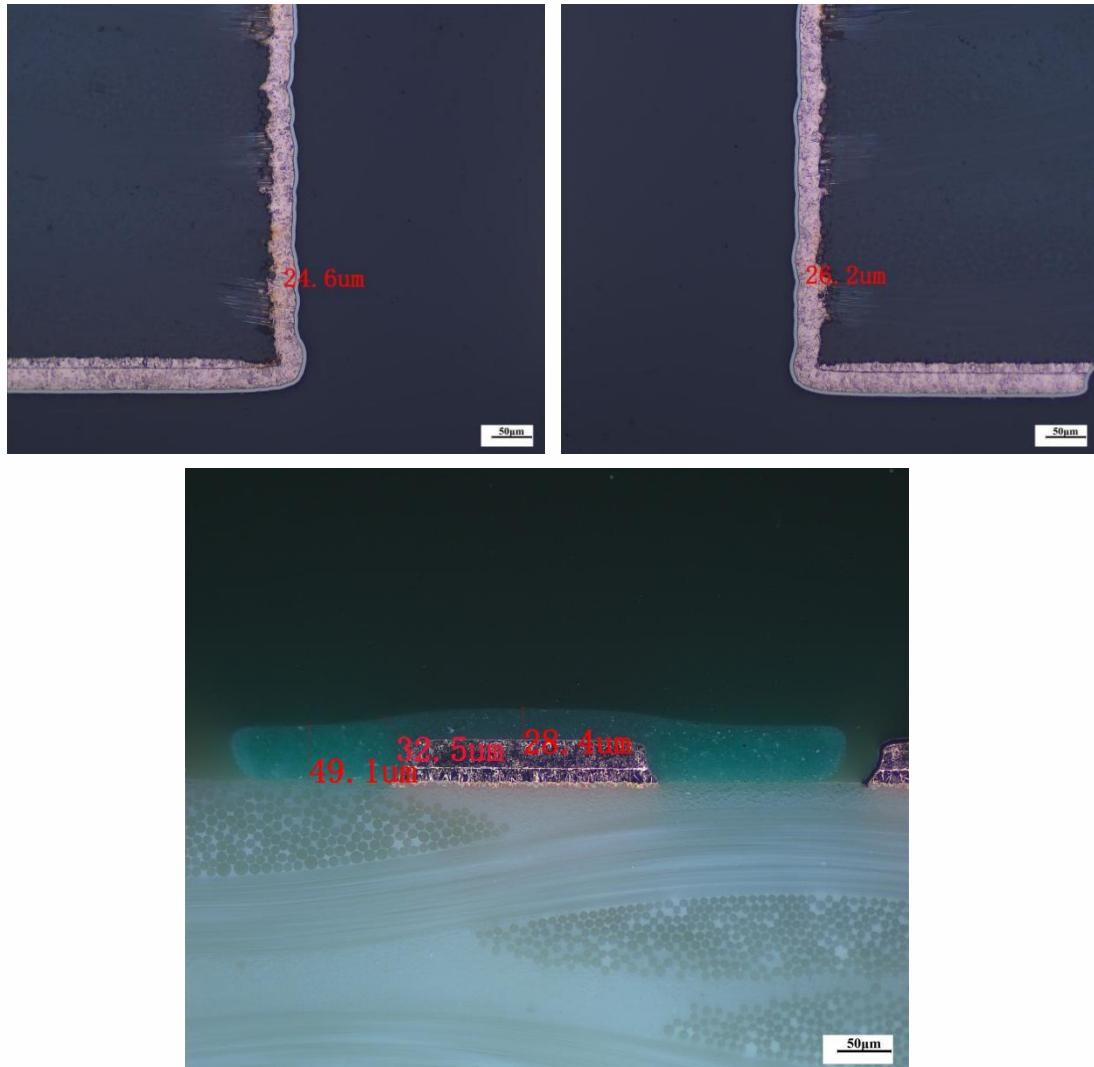
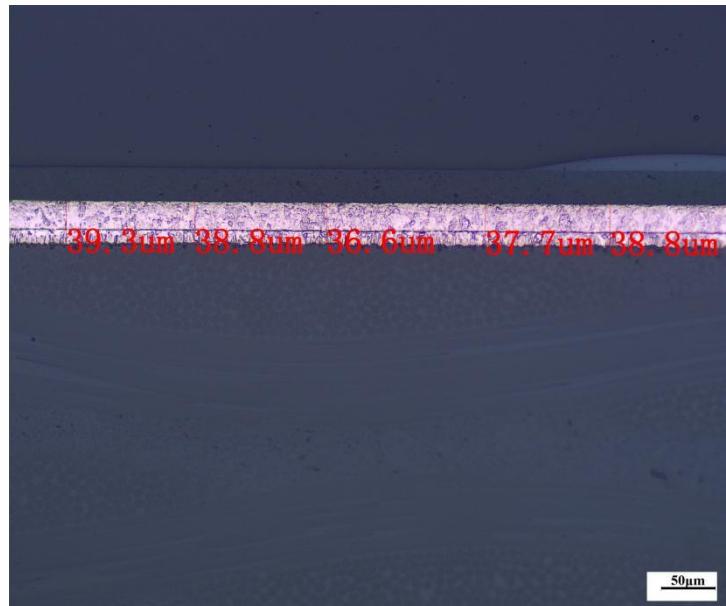
Test photo(s) of sample A2250553251101001 (50X~200X)

Test Sample	Project	Test Results (μm)						
		1	2	3	4	5	6	Avg.
A2250553251101001	Hole Copper	25.1	24.0	24.6	25.1	24.6	26.2	24.9
	Surface Copper	39.3	38.8	36.6	37.7	38.8	/	38.2
	Solder Mask	Base Material		49.1				
		Copper Surface		28.4				
		Corner		32.5
