# Test Report

Report No. A225055325110100101

| No. | Test Item |
|---|---|
| 1 | Voltage resistant |

**3. Test Standard: IPC-TM-650 2.5.7D****4. Test Condition**

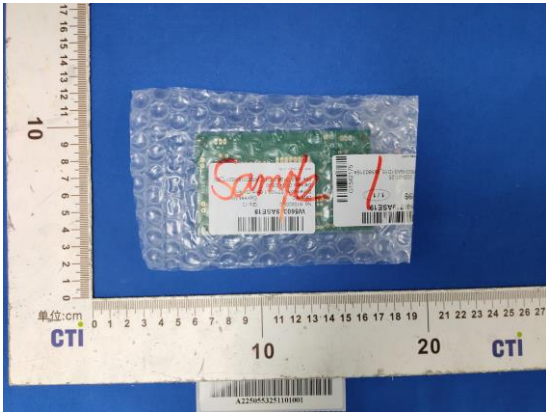
A2250553251101001

Sample Photo(s)

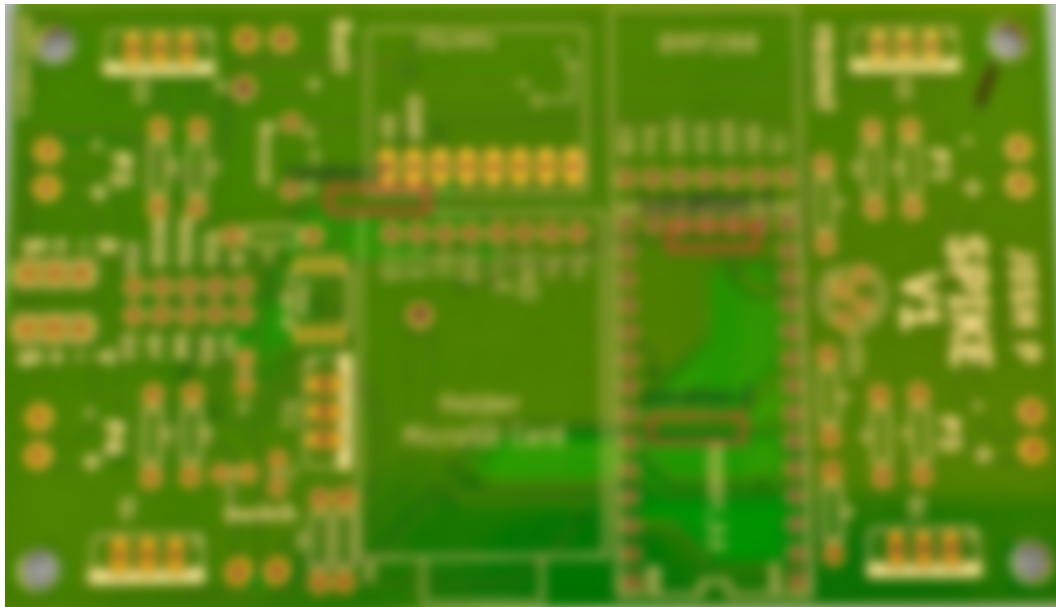
Test Photo:

Test position(s) of sample A2250553251101001

Test voltage: 1000 VDC; Test duration: 1 min; Voltage rise rate: 100 V/s; Leakage current: 10 mA.

| Test Sample | | Test Result |
|---|---|--|
| A2250553251101001 | 1 | No flashover, sparkover and breakdown phenomenon |
| | 2 | No flashover, sparkover and breakdown phenomenon |
| | 3 | No flashover, sparkover and breakdown phenomenon |
