Test Report

Report No. A224067456610100102

Test Item: Dimension

3. Test Standard: IPC-TM-650 2.2.6A

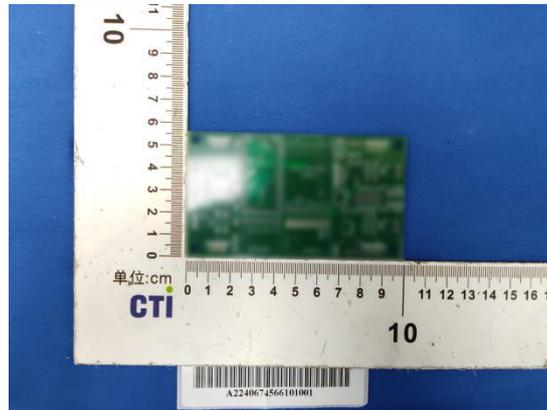
A2240674566101001

Sample Photo(s)

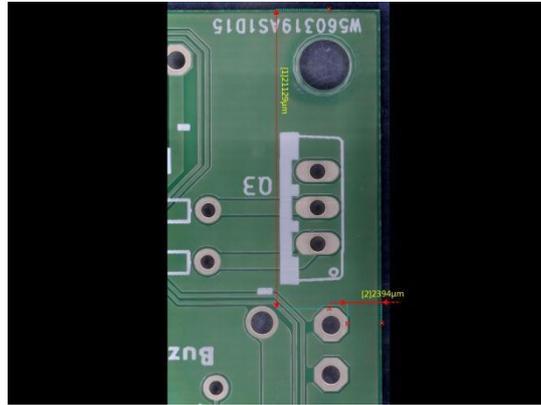
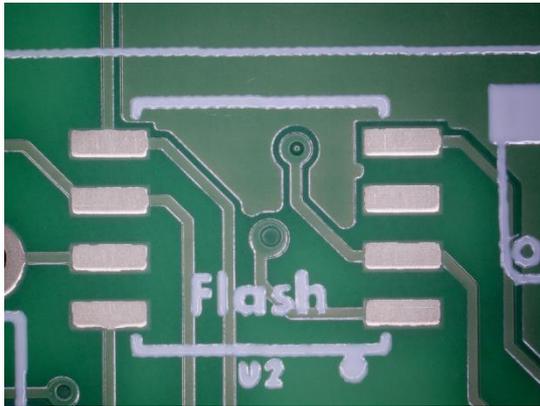
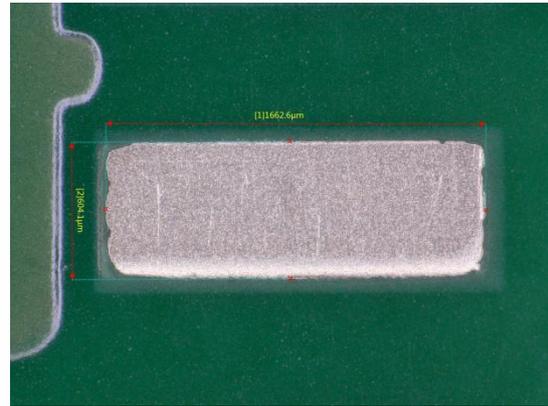
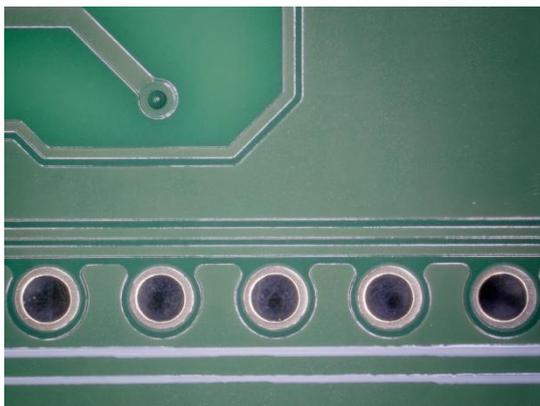
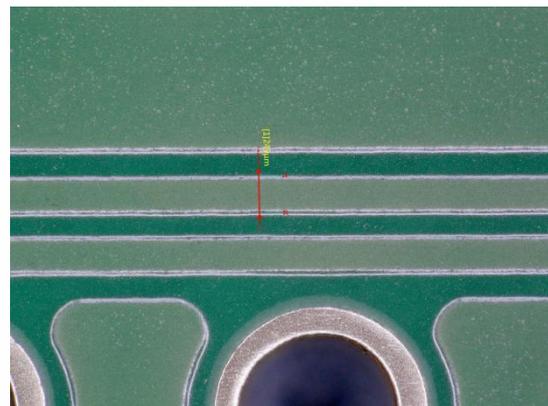
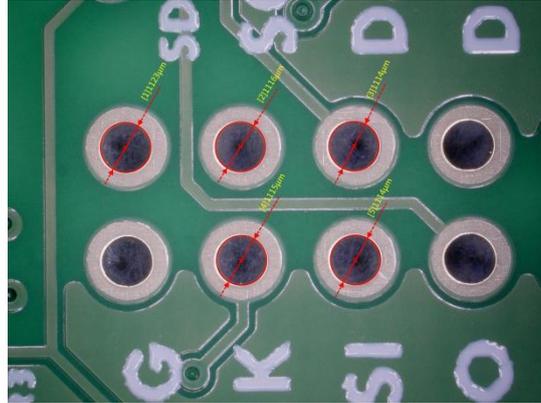
Test photos:

Test sample		Test results (mm)					
A22406745661010 01	PCB long	99.83					
	PCB width	56.85					
	Hole-long side	2.394					
	Hole-width side	21.129					
	Welding plate	Long	1.663				
		Width	0.604				
	Line width	0.249					
	The diameter of the hole	1	2	3	4	5	
	1.123	1.116	1.114	1.115	1.114

Test photo(s) of sample A2240674566101001 (30~150X)
